**OCHOCO IRRIGATION DISTRICT
OCHOCO MAIN CANAL**

**CANAL LINING DEMONSTRATION PROJECT
Exposed 160-mil Coletanche NTP 2 ES
NOVEMBER 14 - 16, 2000**

Jay Swihart and Jack Haynes
January 2001

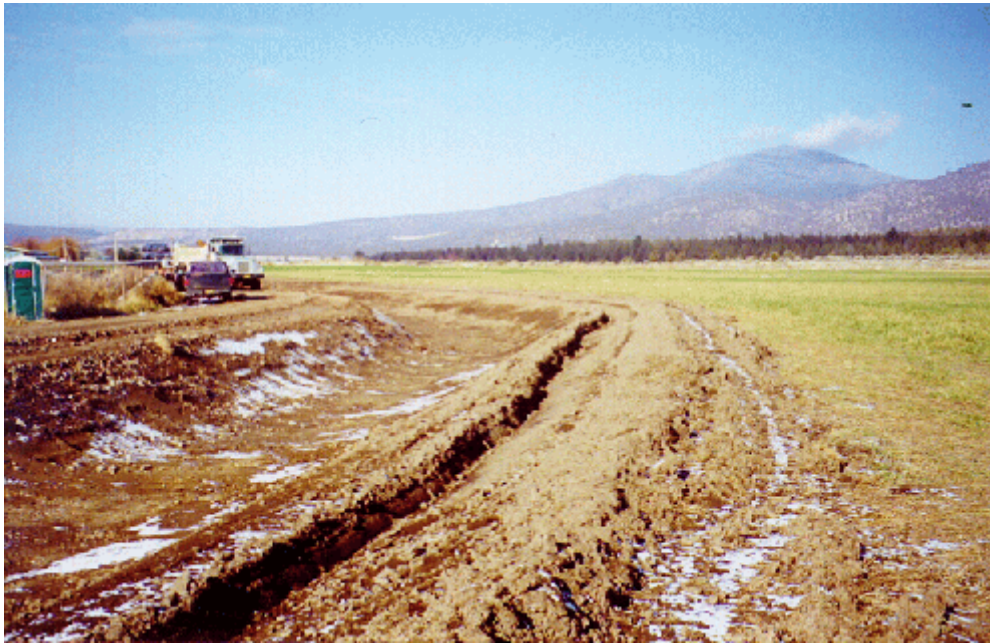
Photograph 2 - Irrigation district reshaped the canal prism, restored the 1½:1 sideslopes, and cut a 6-inch deep V-notch anchor trench on each bank.

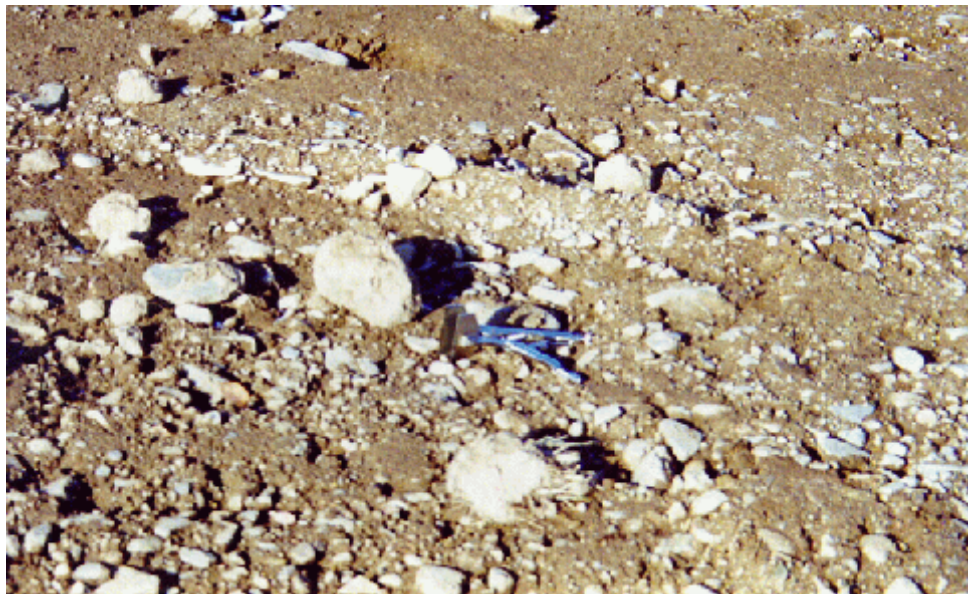
Difficulties:	The subgrade was quite irregular with offsets up to 6 inches. Seaming over these large offsets was challenging.
Unit Cost Estimate:	Exposed 160-mil Coletanche = \$1.51 per square foot (\$0.93 Coletanche + 0.26 preparation + 0.10 installation + 17% OH & profit)

Photograph 3 - Subgrade was quite rough with offsets up to 6 inches.

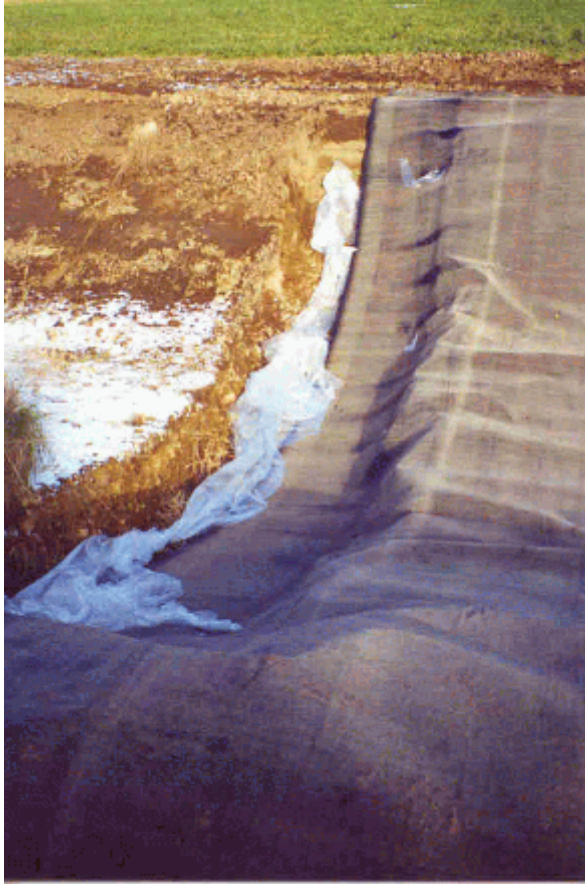
Photograph 4 - Geomembrane is placed into the cut-off trench at the downstream end of the test section.

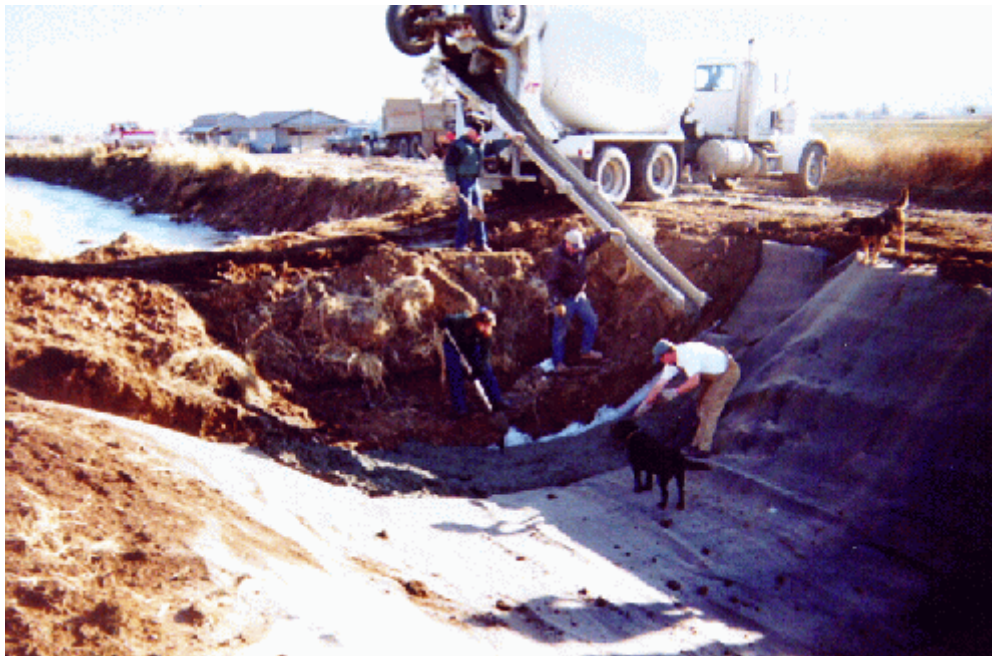
Photograph 5 - Concrete placed over geomembrane in the upstream cut-off trench.

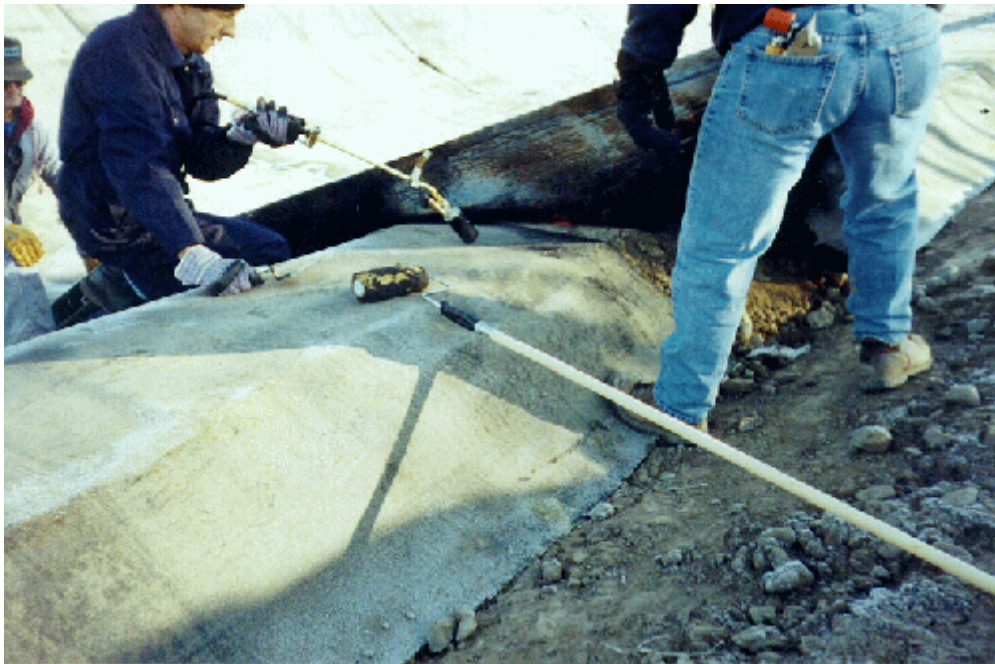
Photograph 17 - Propane torch used to seam the geomembrane.

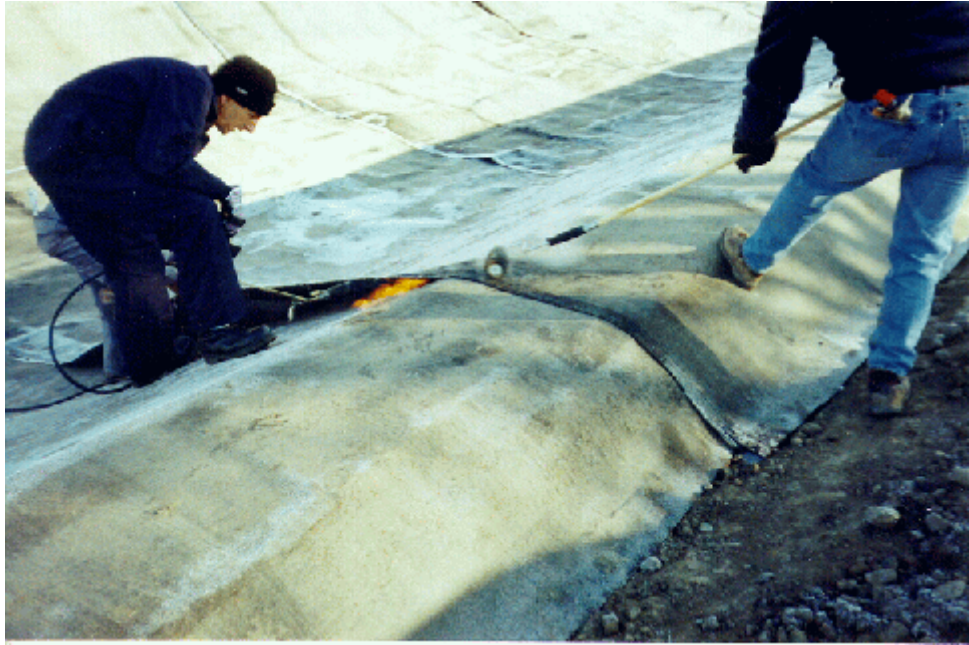
Photograph 18 - After heating with the torch, seams are pressed together with a paint roller.

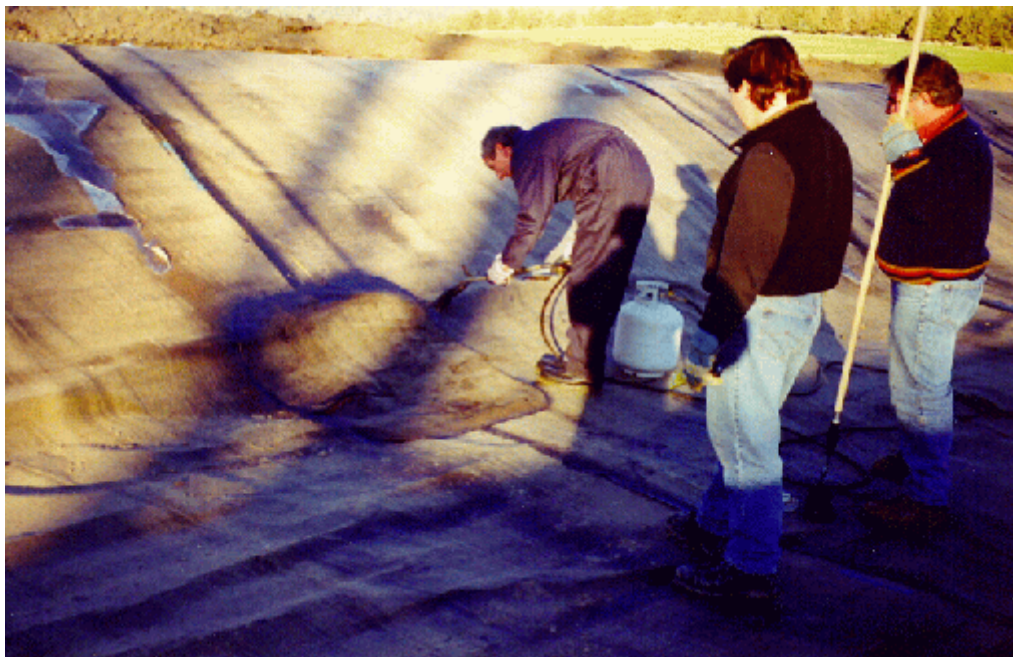
Photograph 19 - Seamer places a large patch over a wrinkled seam caused by uneven subgrade.

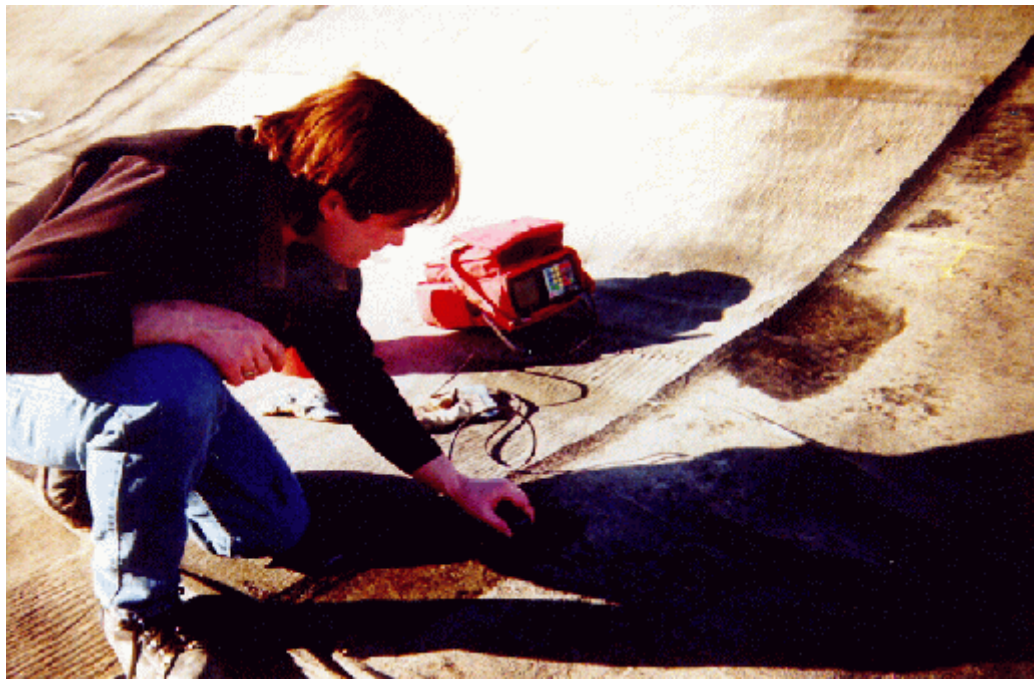
Photograph 20 - Ultrasonic equipment was used to test about 10% of the seams. Although all seams were water tight, small voids within the 8 inch overlap were detected due to the uneven subgrade.

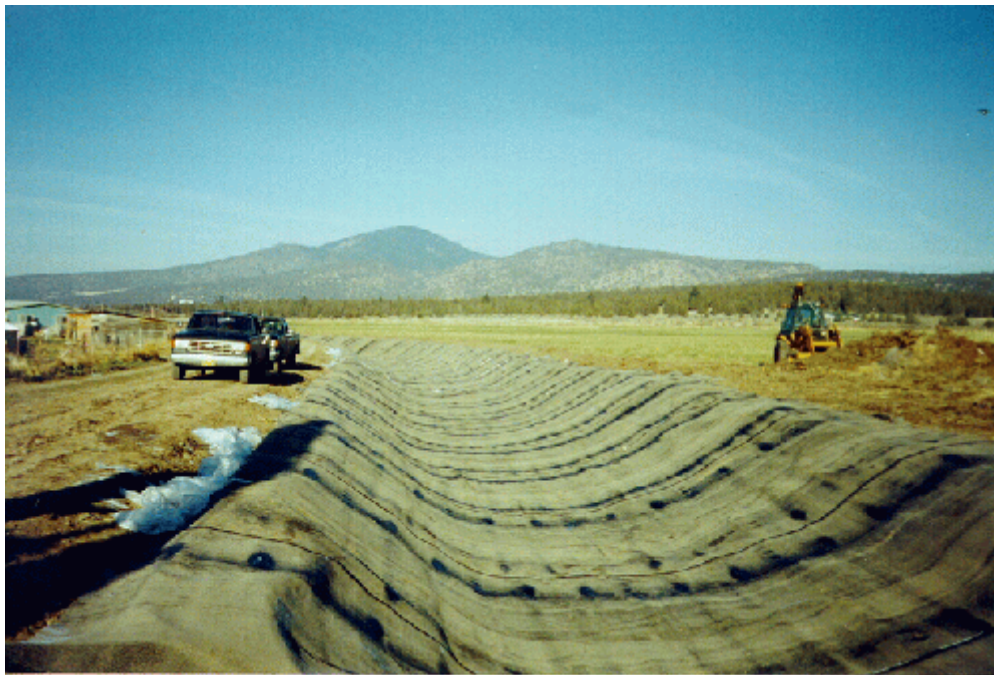
Photograph 23 - Finished COLAS test section.
